System of diesel Engine Performance Analysis (2 nd)

SEPA II

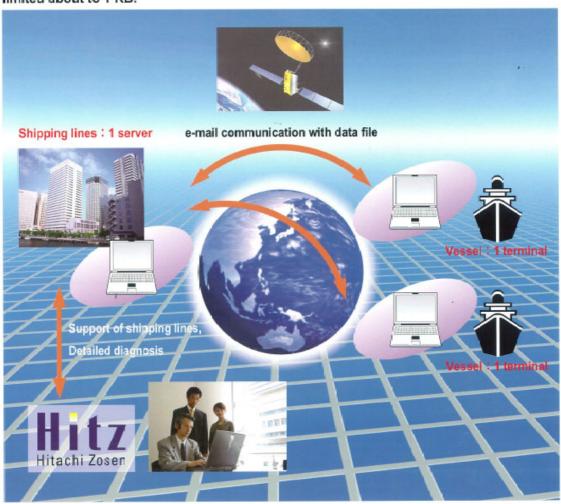
e-mail communication with data file

Communication expenses are economized, because the capacity of 1 performance data is limited about to 1 KB.

The capacity of 1 performance data is limited about to 1 KB. By communication with only 1 KB data file, at anywhere of the vessel, the shipping company and Hitachi Zosen, the same graphs and images can be shared to monitor.

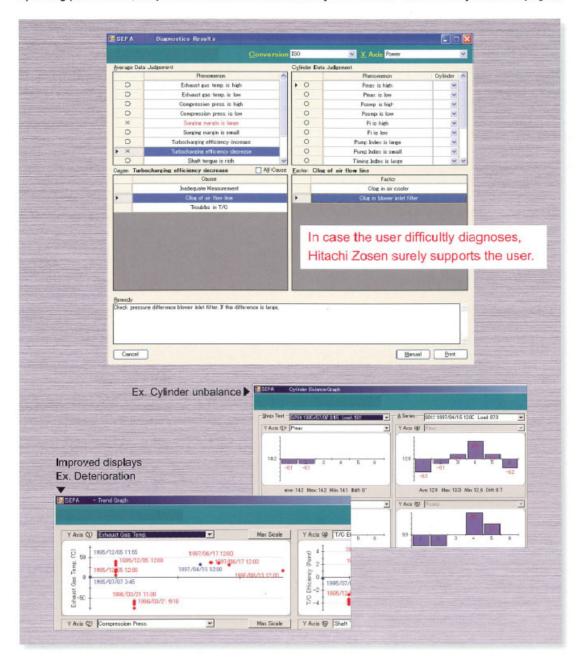
Advanced automatic diagnosis

Engine operating data at sea are compared with shop data. In case there are some irregular phenomena out of operating past records, the possible causes can be focused by SEPA II user. Quick remedy is also displayed.

With using the same graphs, the SEPA II's diagnosis agrees with an engineer's diagnosis.

The fault analysis trees drawn from our experience and the threshold values based on the shipping quality standards are integrated in the automatic diagnosis algorithm.

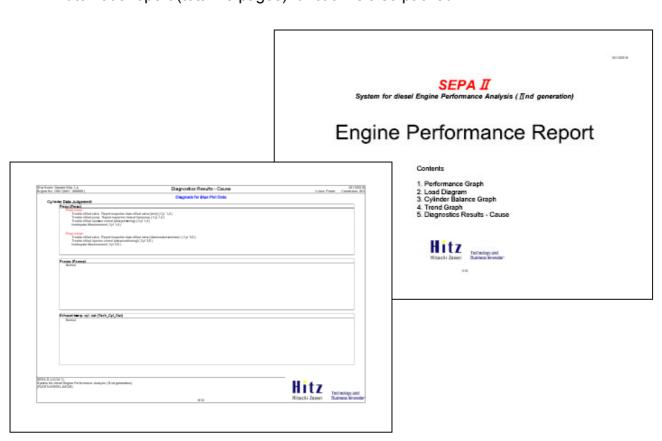
Automatic report (total 10 pages) function is also packed.

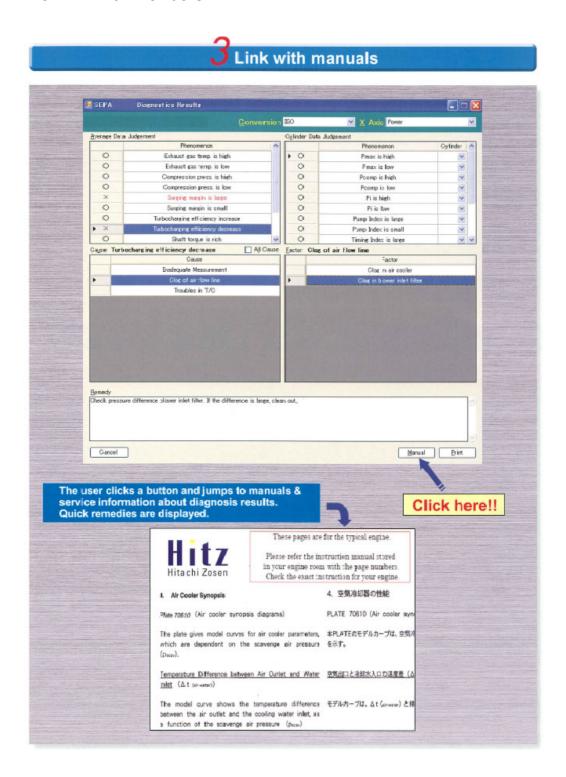
1.3 Link with manuals

The user can jump to manuals and service information about diagnosis results and remedies. As these images are installed in the user's personal computer, no stress is felt about the communication cost.

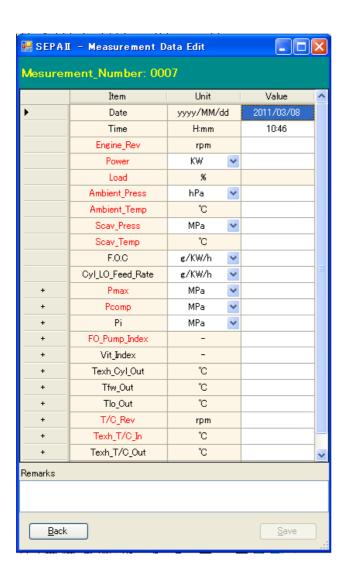
3. Input Data to be required

Only the same input data as main engine performance data sheet is required for the engine performance analysis.
